DC-17-02998

SUZANNE CALLAWAY-DAVIS

AMAZON.COM LLC, OLADAYA  
ANIPOLE, INPAX SHIPPING  
SOLUTIONS INC., AND INSS, LLC*Defendants*§  
§  
§  
§  
§  
§  
§  
§  
§

**PLAINTIFF SUZANNE CALLAWAY-DAVIS' ORIGINAL PETITION**

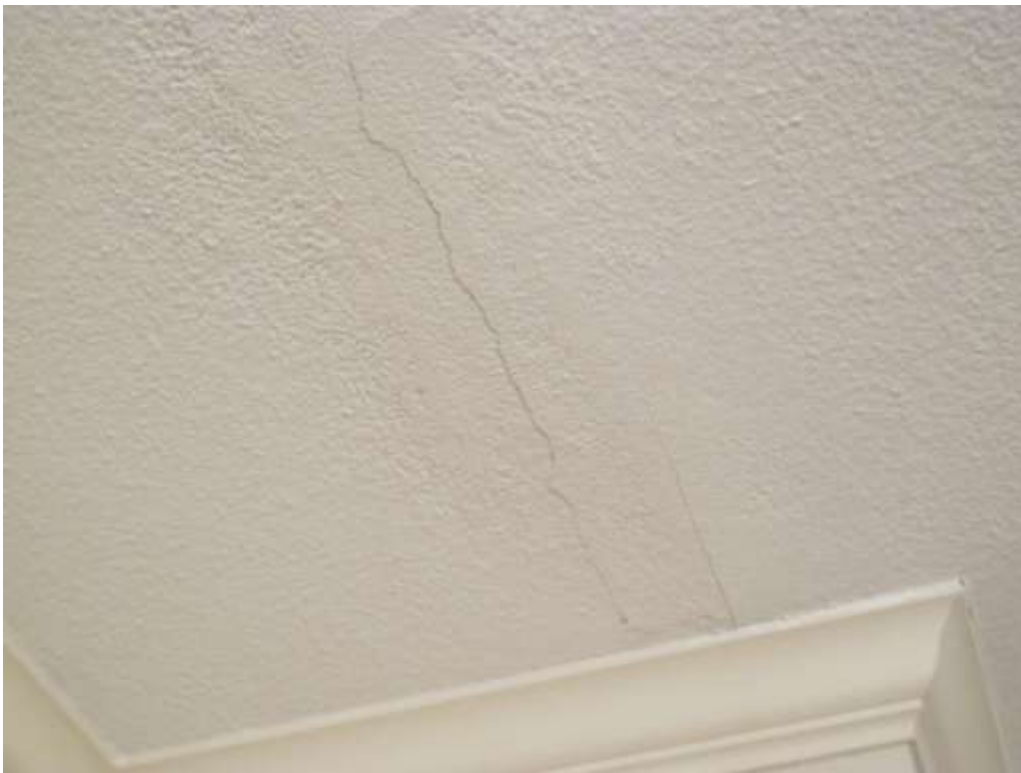
Photo 28: New interior ceiling cracks adjacent to impact area.

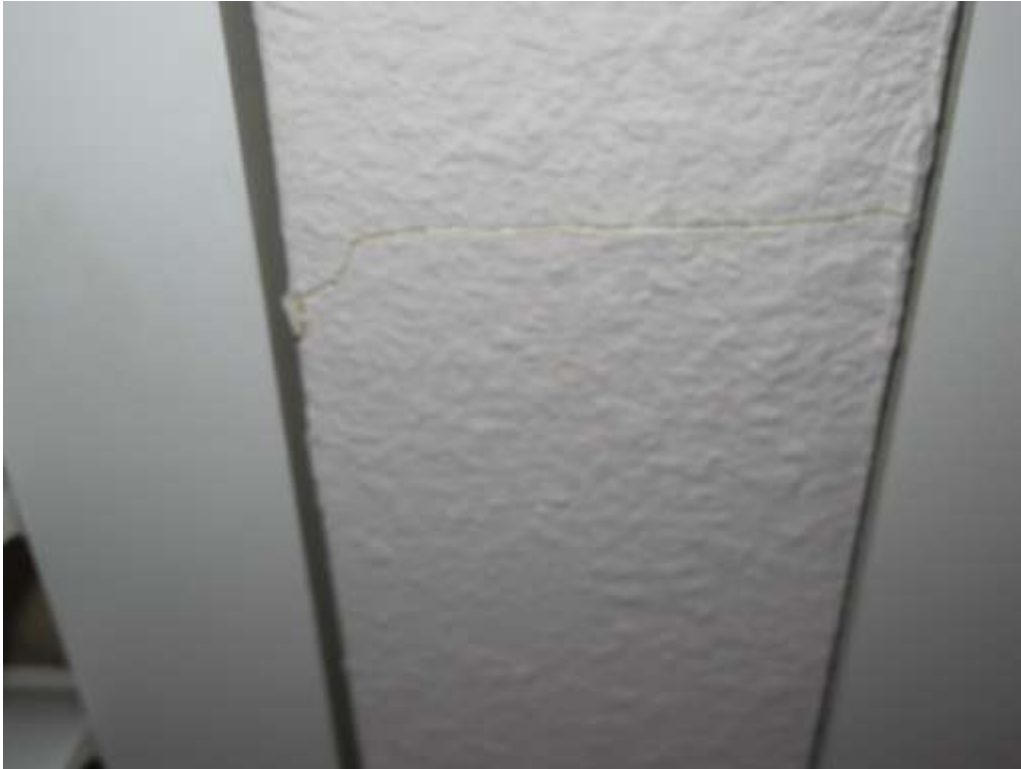
Photo 29: New interior wall cracks adjacent to impact area.

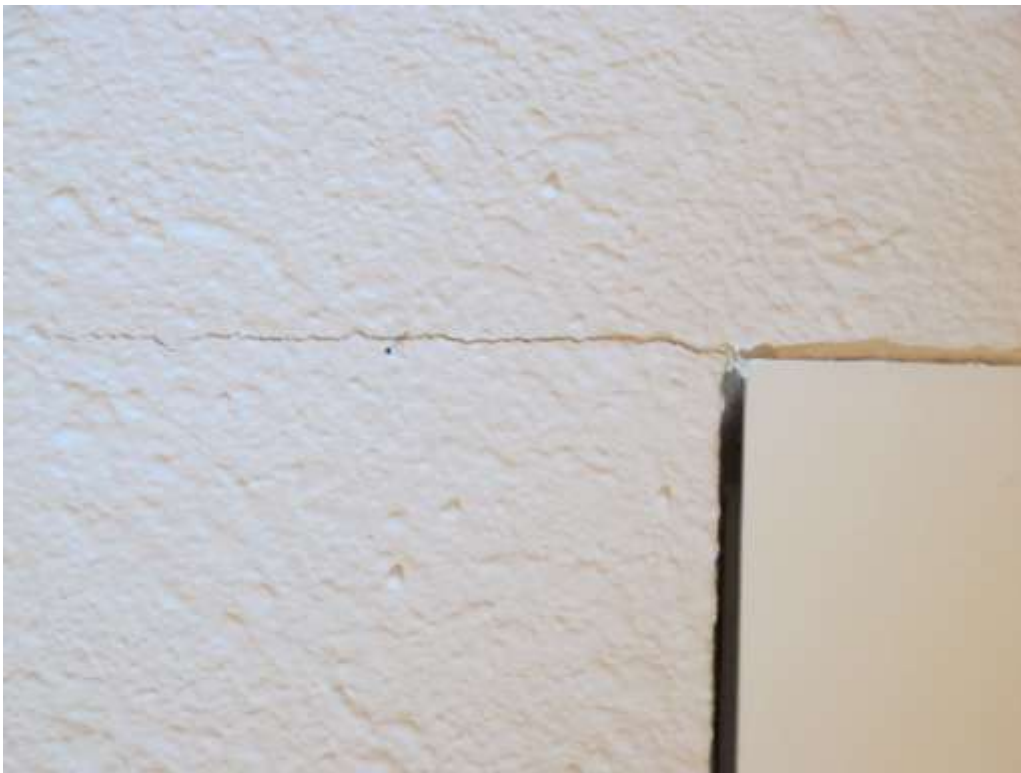
Photo 30: New interior cracks adjacent to impact area.

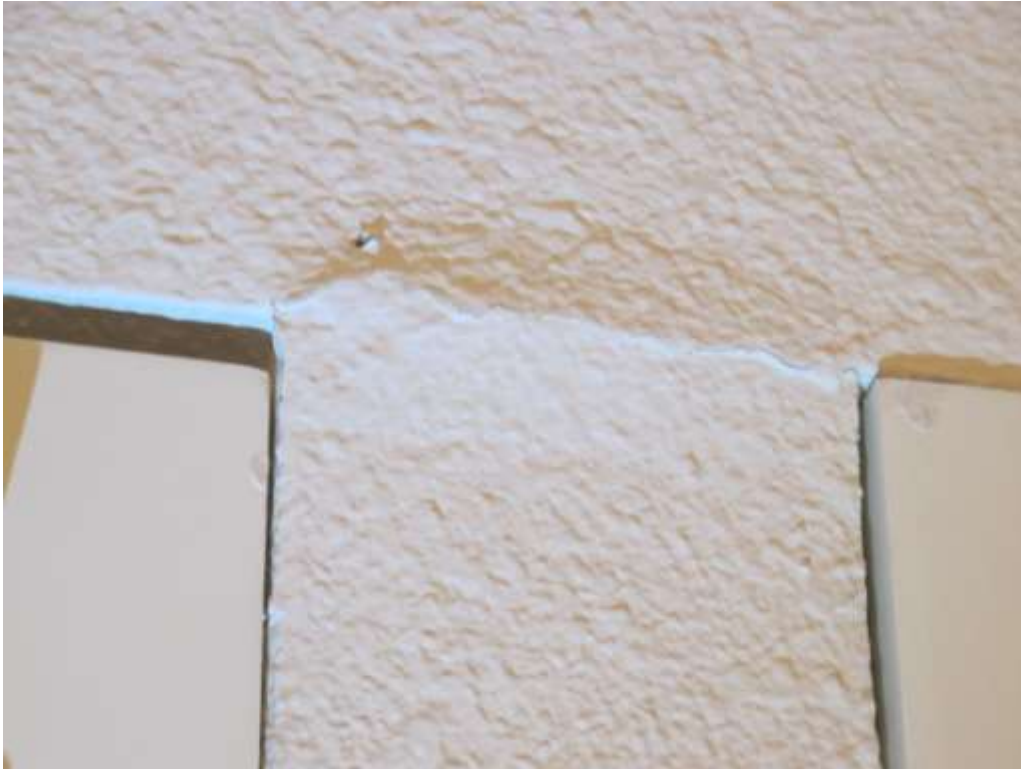
Photo 31: New interior cracks adjacent to impact area.

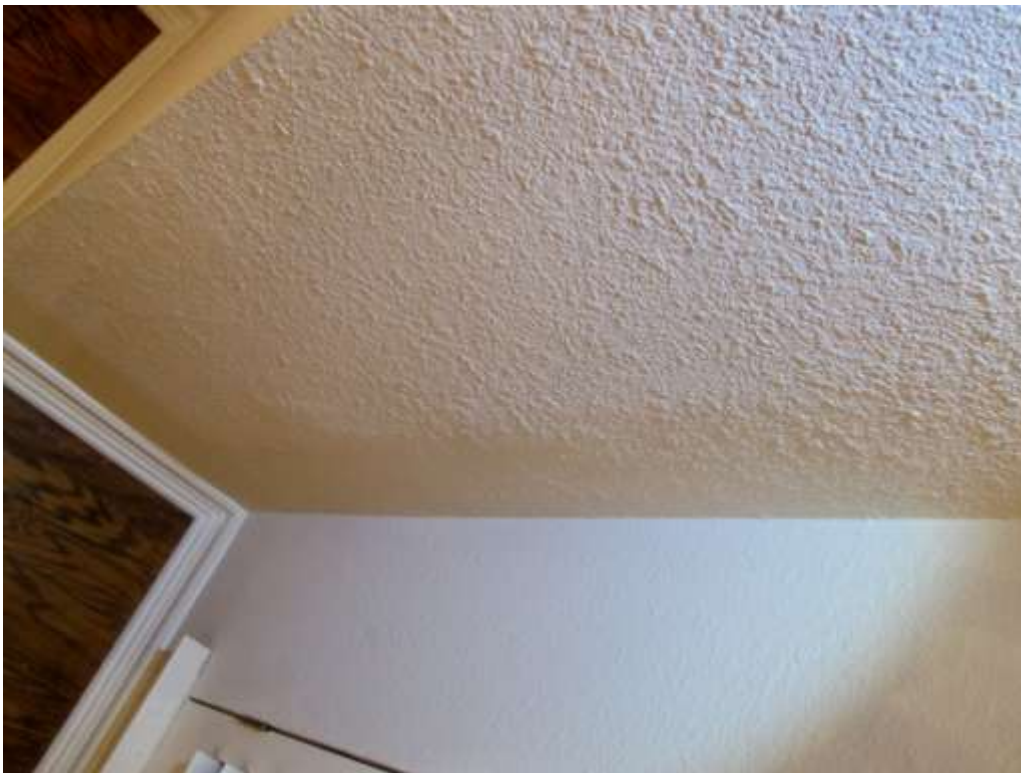
Photo 32: Bowed wall area adjacent to impact area.

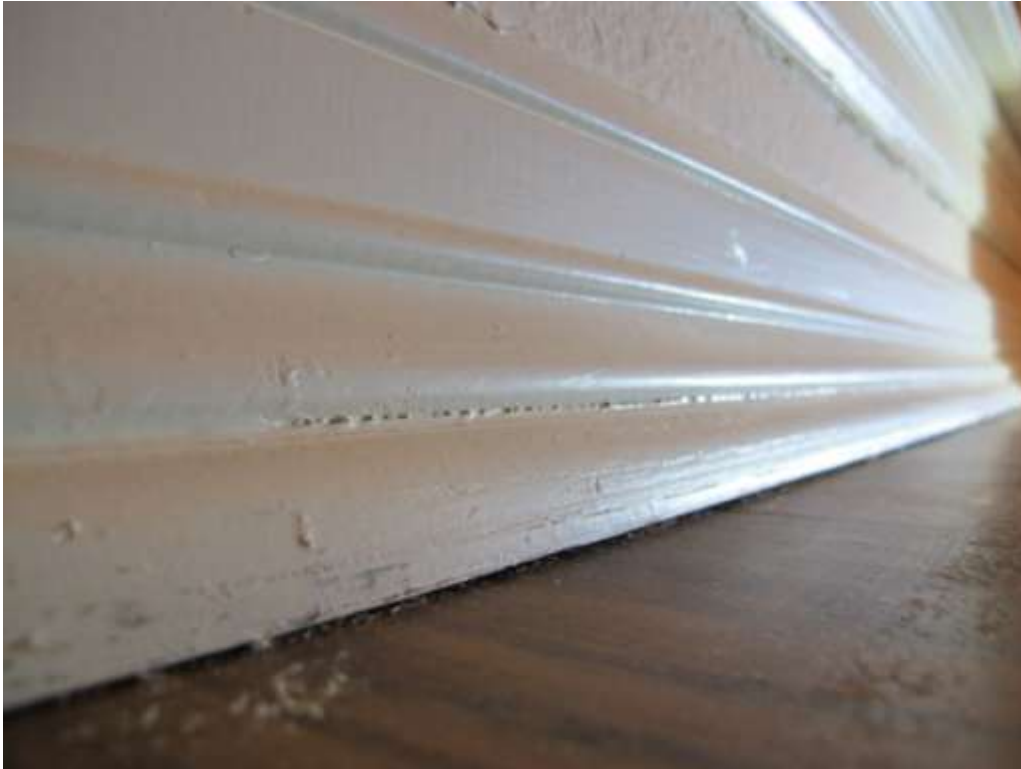
Photo 33: Base molding gaps at the uneven areas of the hardwood floor.

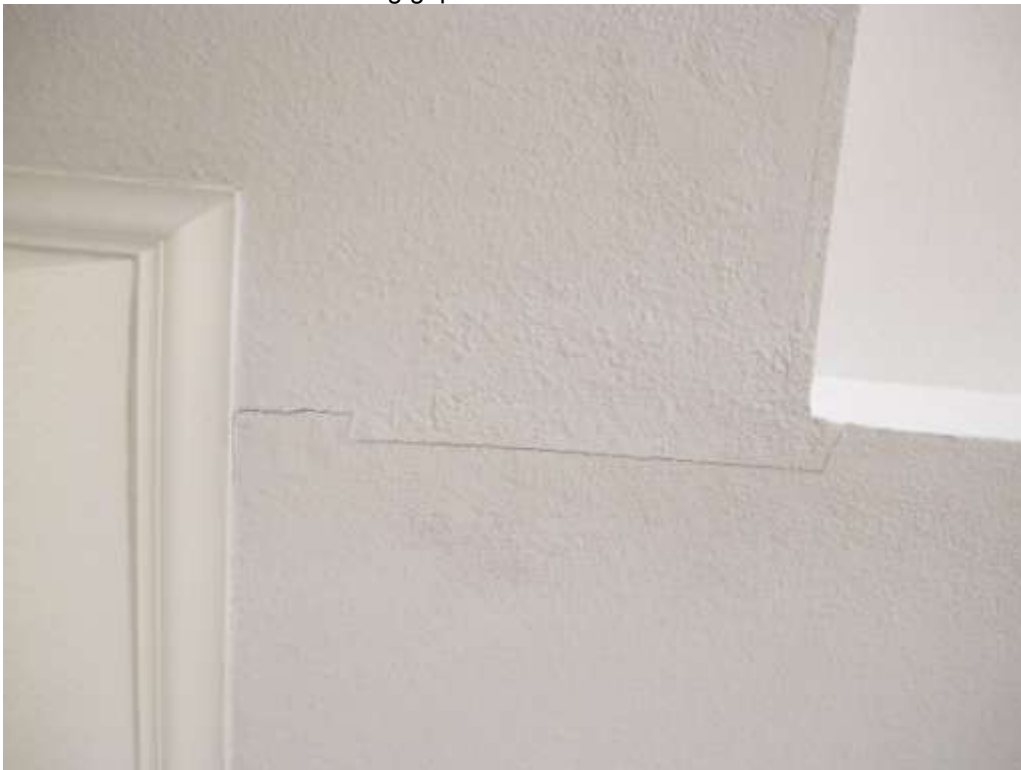
Photo 34: New interior ceiling cracks adjacent to impact area (dining room).

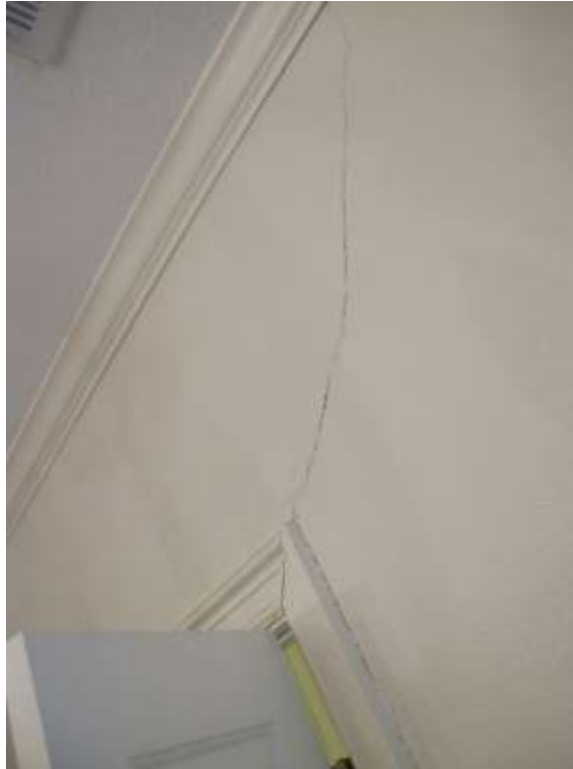
Photo 35: New wall crack and trim separation in the dining room at the entry to the kitchen.

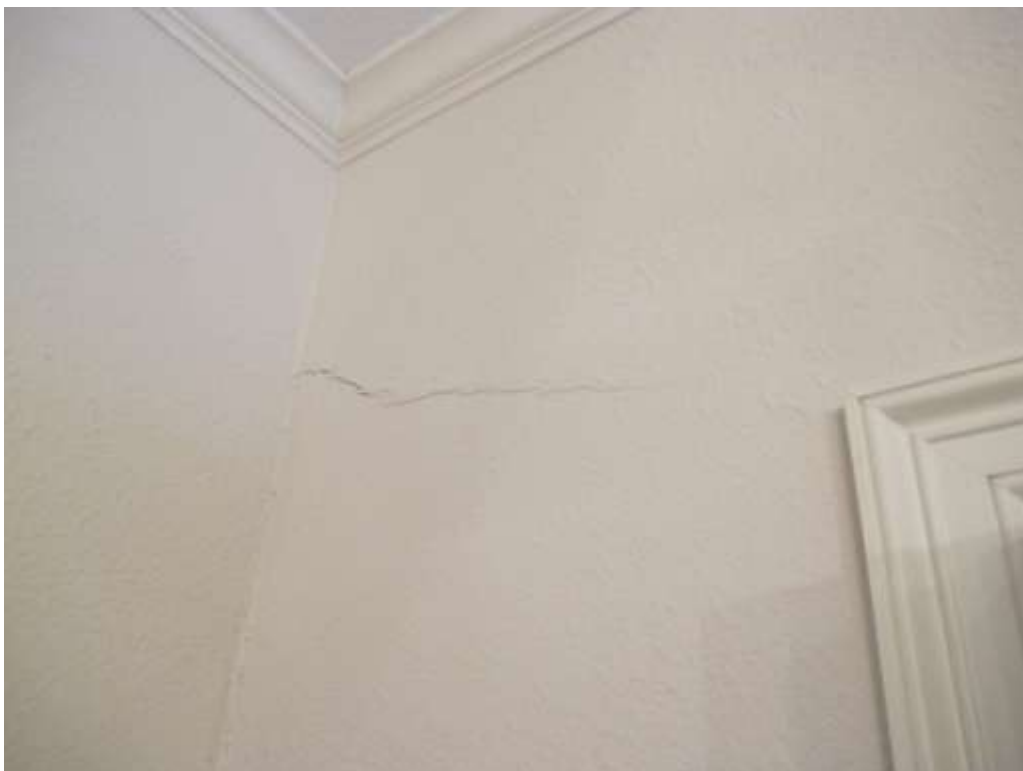
Photo 37: New interior wall crack in the dining room at the entry to the kitchen.

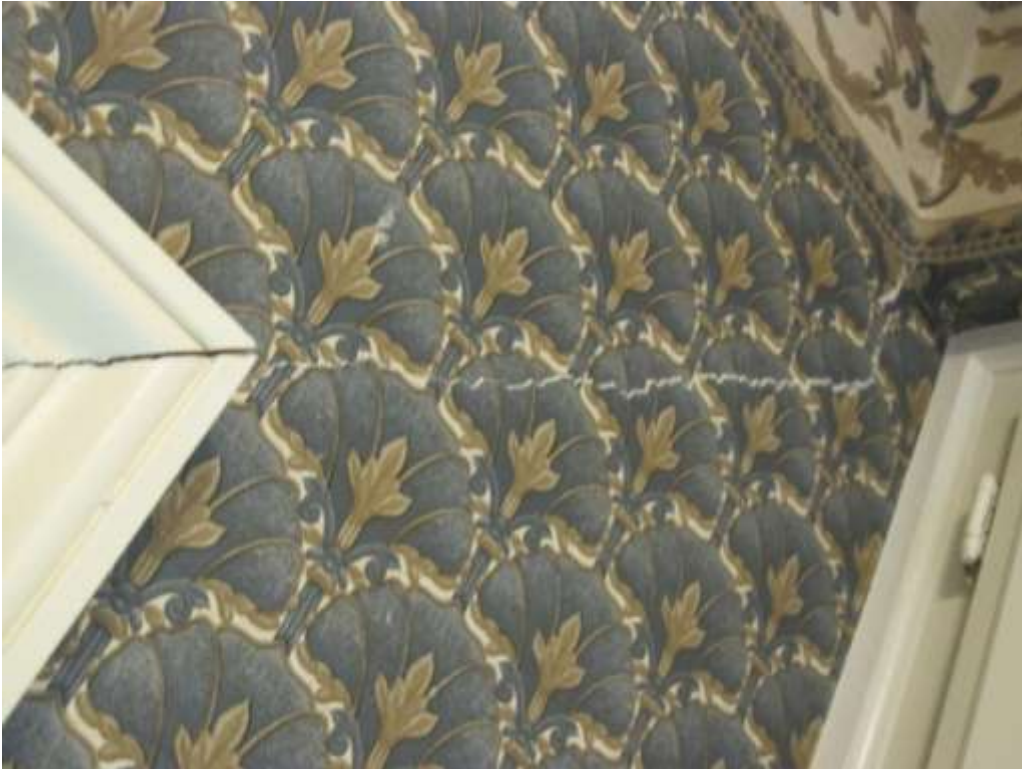
Photo 39: New wall crack and trim separation in the kitchen at the entry to the dining room.

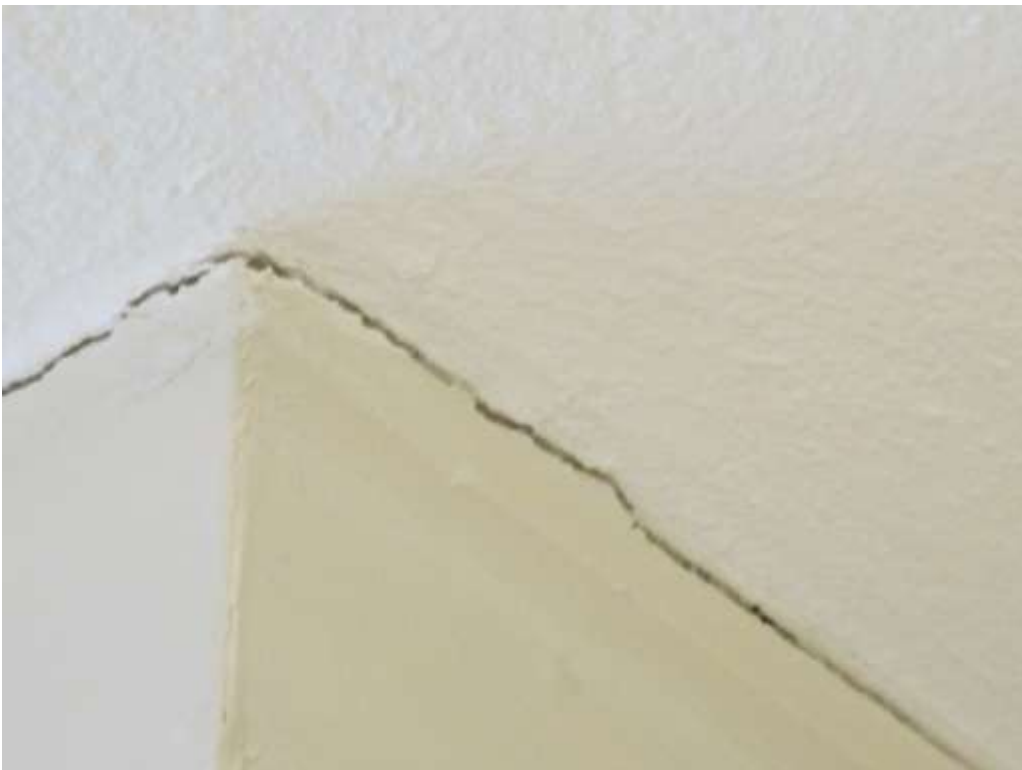
Photo 40: New wall and ceiling separation in the kitchen near the entry to the dining room.

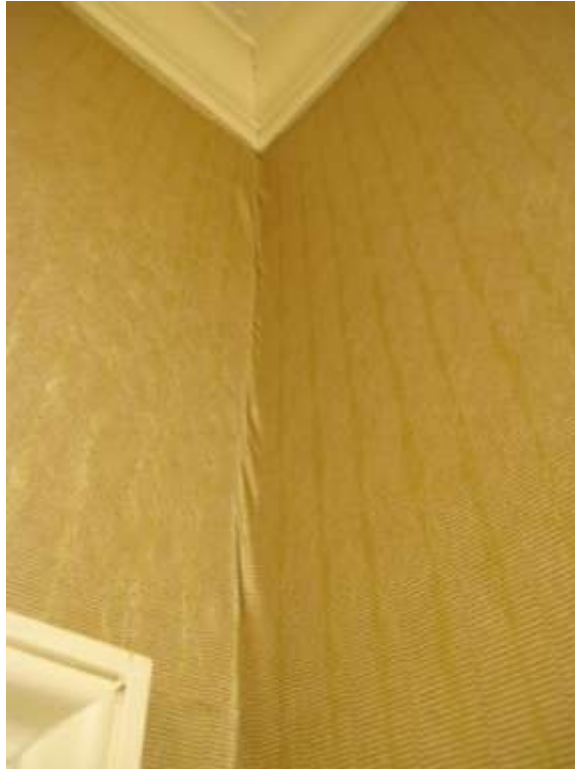
Photo 41: Corner separation at the bathroom opposite the cracks in the dining room wall.

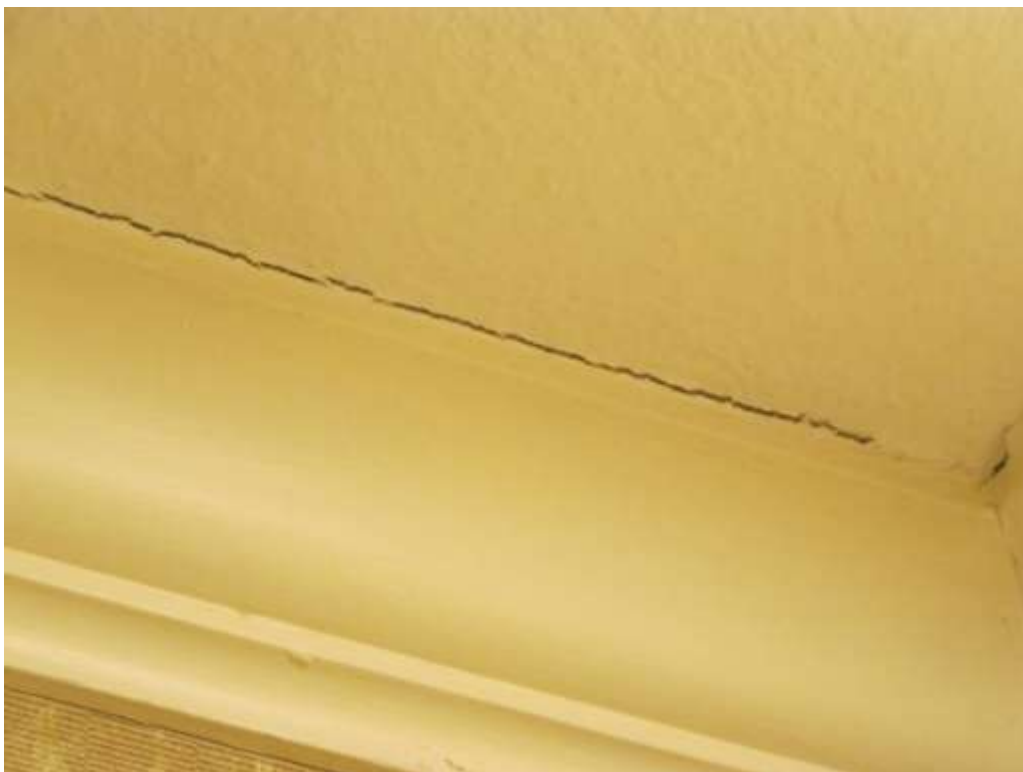
Photo 42: New crown molding separation at the bathroom opposite the dining room wall.

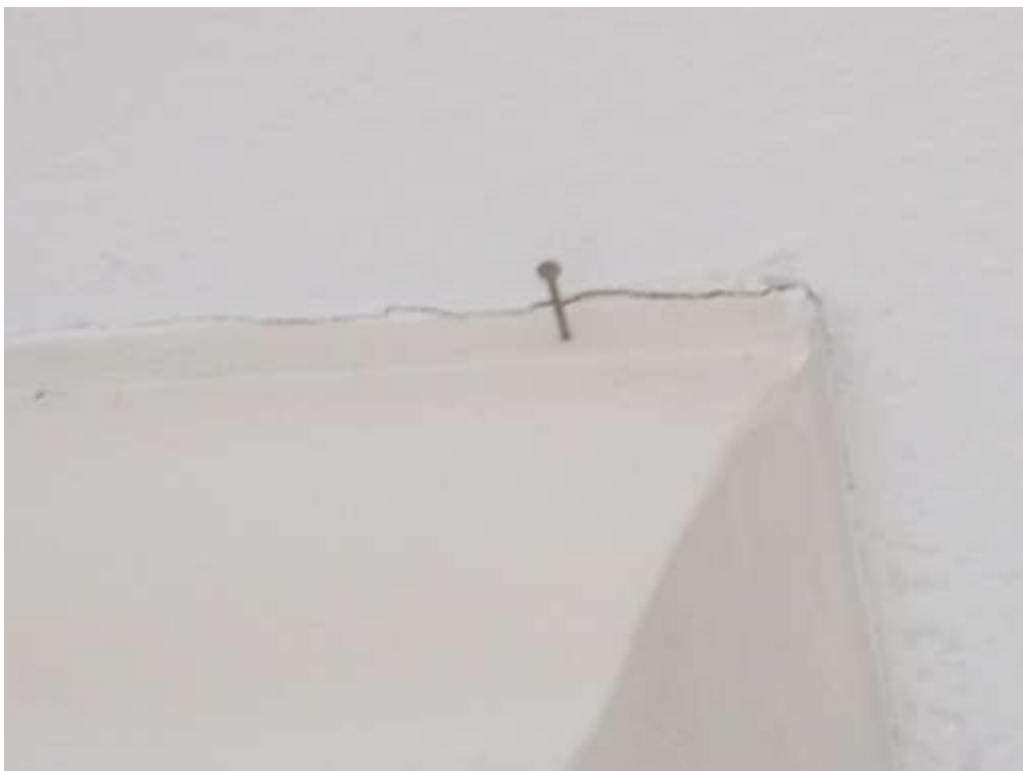
Photo 43: Separation at the wall ceiling junction in the dining room entry from the hallway.

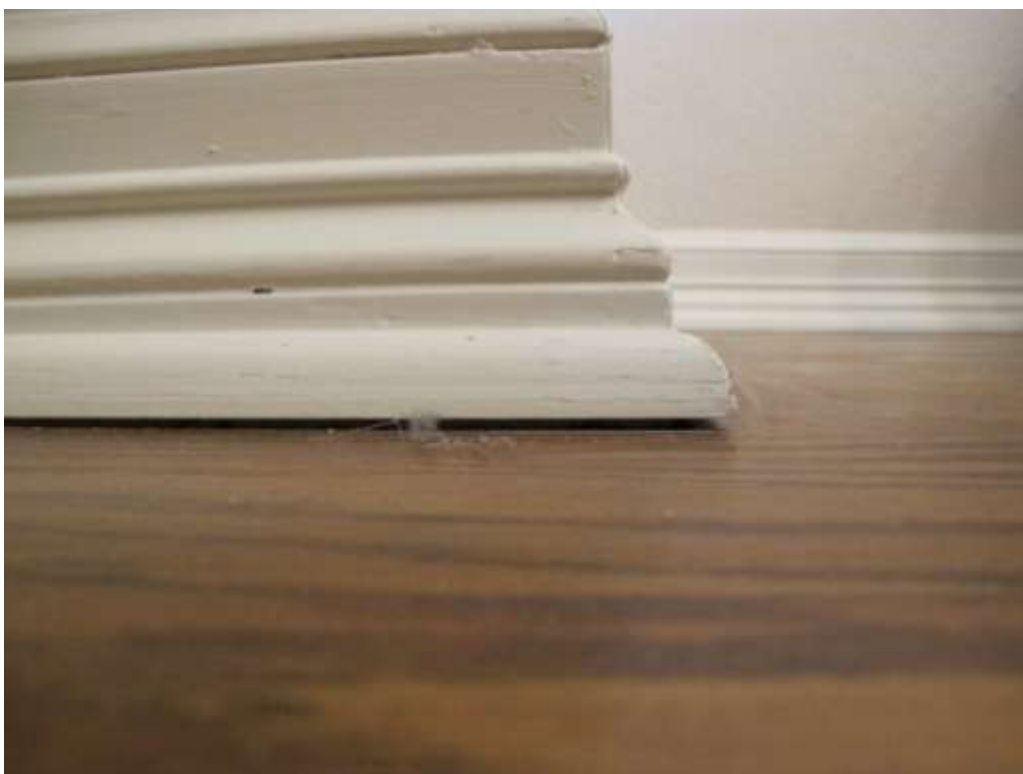
Photo 44: Uneven flooring and base molding gap adjacent to the impact area.

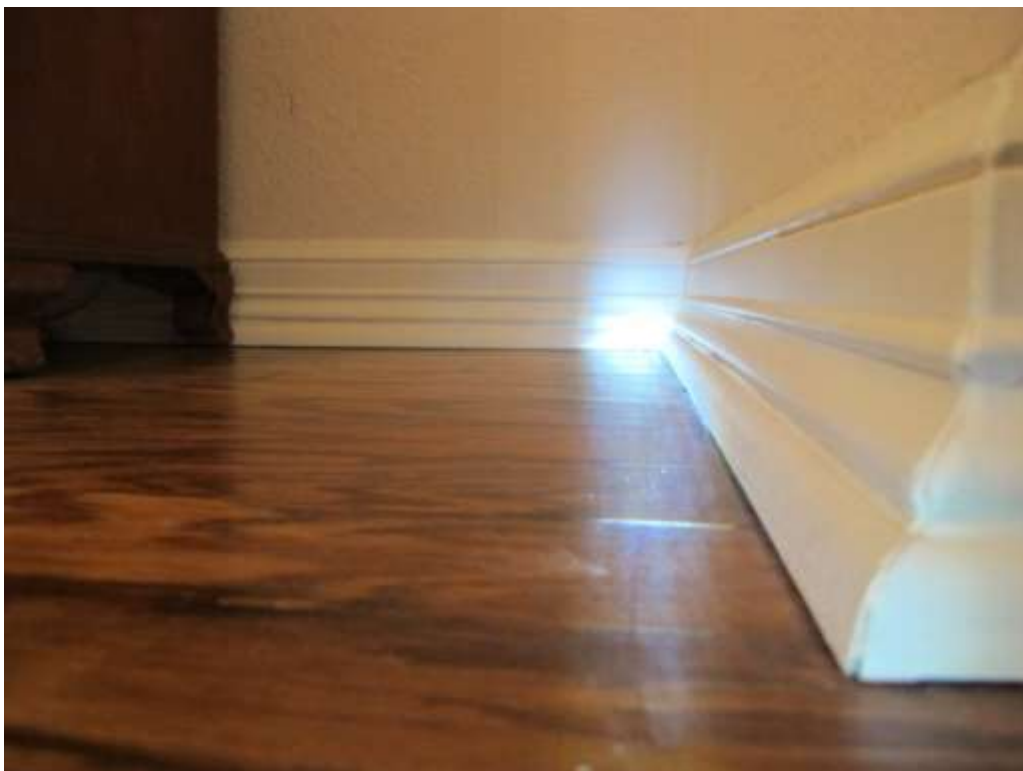
was bowed, cracked, and separated. Mr. Becker observed that new cracks and separations were observed in the interior, consistent with the deflection of vibrations due to the impact of the vehicle, causing stress cracks and fractures. Mr. Becker also observed that the hardwood floor shows evidence of cupping due to the sprinkler water.

Photo 45: Cupped flooring at the impact area where rainwater intruded.

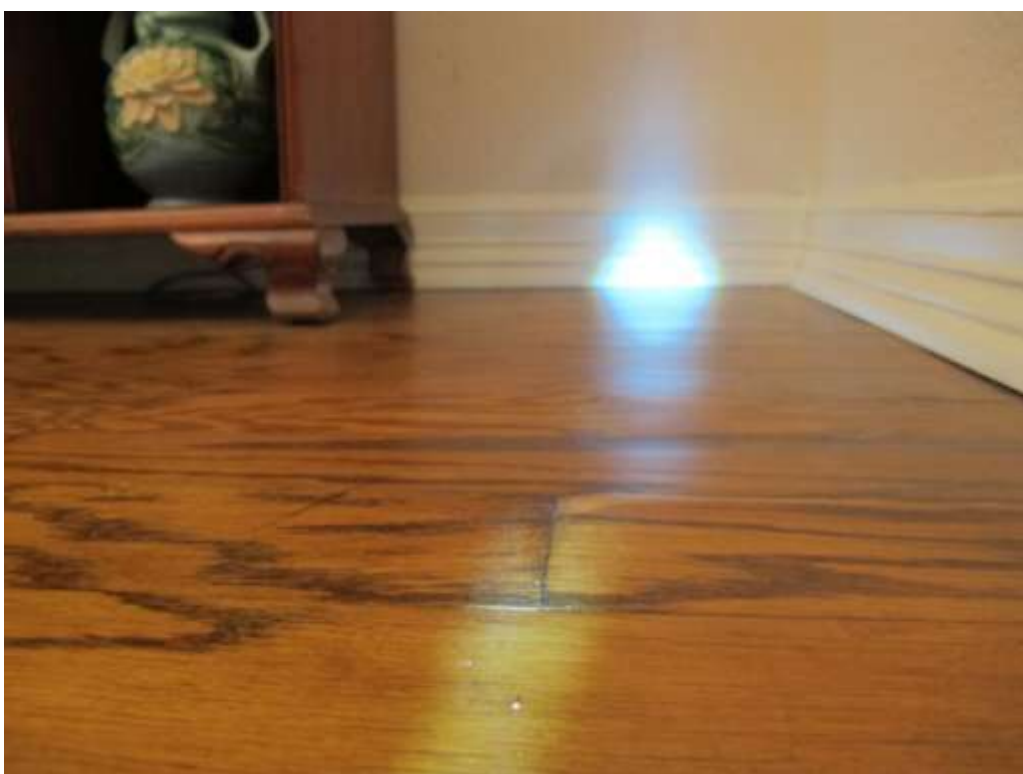
Photo 46: Cupped flooring at the impact area where rainwater intruded.
